TECHNICAL NOTE 3685

FATIGUE CRACK PROPAGATION IN SEVERELY NOTCHED BARS

By W. S. Hyler, E. D. Abraham, and H. J. Grover
Battelle Memorial Institute

Washington June 1956

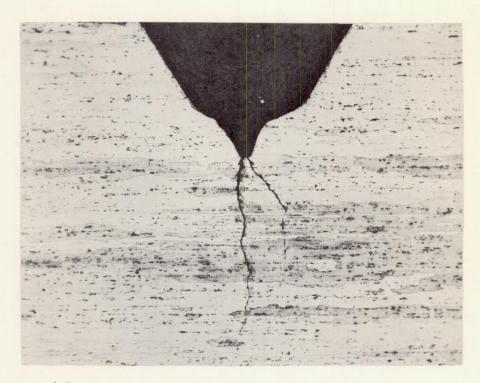
At about 5×10^6 cycles, the test was stopped to examine the notch root. Considerable debris was observed at the notch root and also direct evidence of a gaping crack. The notch root was photographed and the specimen was sectioned and examined metallographically. Figures 4 and 5 show the nature of the notch root after about 5×10^6 cycles of reversed 22.5-ksi stress. The following observations summarize essential details of the three photographs:

- (1) Two almost continuous cracks traverse the notch root circumferentially.
- (2) Occasional areas exist at the notch root from which large pieces of material appear to have fallen out.
- (3) Fatigue cracks initiated on the surface some distance away from the minimum section diameter.
- (4) Propagation of the cracks was toward the center of the bar and in some cases was such that cracks joined, enabling material between the cracks to fall out.
- (5) As a result of deformation during cyclic stressing the contour of the notch root was changed from circular to U-shaped as shown in figures 5(a) and 5(b).

Figure 4.- Photograph of notch root of 2-inch-diameter specimen after 5×10^6 cycles of reversed 22.5-ksi stress.

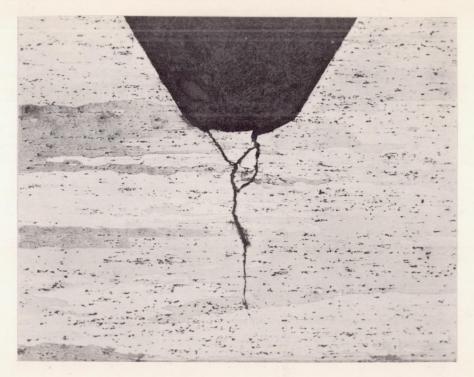
The depth of crack penetration was found to be in the range 0.040 to 0.044 inch. The average crack depth (from two measurements) was 0.042 inch.

(a) Section showing cracks traversing notch root.

Figure 5.- Photomicrograph of notch root of 2-inch-diameter specimen after 5×10^6 cycles of reversed 22.5-ksi stress.

(b) Section showing crack propagation and separation of pieces of material.

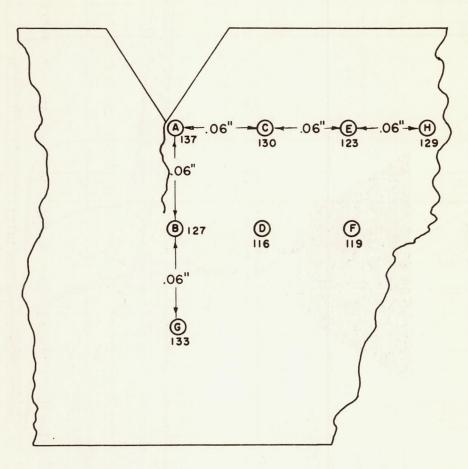
It was thought that extreme fibering of structure might produce the observed behavior. However, examination of a typical section of the structure yielded no proof of such a markedly fibered material. Other metallographic study (for example, hardness measurements) did not disclose positive reasons for observed behavior. Figure 6 shows Knoop hardness numbers taken at various locations on the section observed in figure 4. No trend in hardness gradient was observed in any direction.

Figure 6.- Knoop hardness numbers on cross section of notched specimen shown in figure 4.

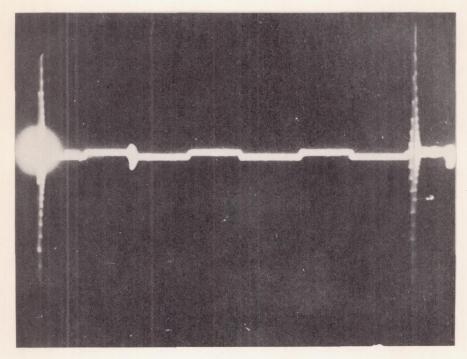
Two of the bars lettered C were submitted to the metallographic laboratory for examination. The bar numbered C7 had a trace on the Reflectoscope screen as shown in figure 9. In this photograph, the vertical trace at the left represents the initial pulse; that at the right is the reflection at the end of the bar. The small blip near the initial pulse represents reflection from some discontinuity. Since the length between initial pulse and end reflection represented 24 inches on the bar, the distance to the discontinuity could be determined. Measurements of the appropriate distances on the film when converted to inches for the bar suggested the discontinuity to be 6.9 inches from the specimen end.

Figure 9.- Reflectoscope pattern of bar C7.

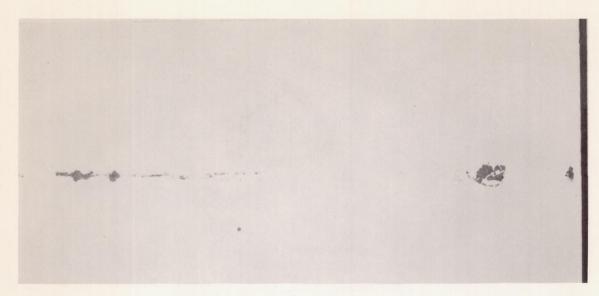
was found. The end view of the inclusion is shown magnified 100 times in figure 10(a). The specimen was remounted and polished from the side to determine the length of the inclusion. It was found to be about 3/32 inch in length. Figure 10(b) shows the side view of the inclusion at 45X.

(a) End view of inclusion; 100X.

(b) Side view of inclusion; 45%.

Figure 10.- Inclusion found in bar C7.

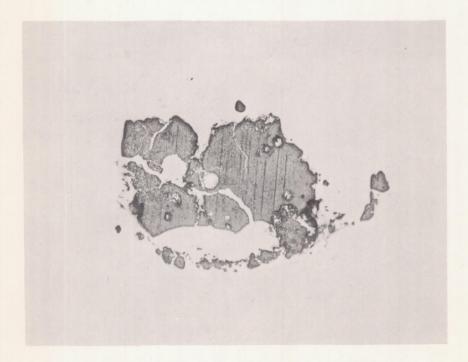
Similar results were obtained on specimen C5. The inclusion found is observed in figure 11.

(a) Side view of inclusion; 15X.

(b) Enlarged view of inclusion; 100X. Figure 11.- Inclusion found in bar C5.
